## Residential Pre-purchase Inspection Report

Date of inspection: Monday, 24 June 2013 09:00 AM

Prepared within the limitations and conditions specified in  
Australian Standard AS 4349.1 - 2007 Pre-purchase Inspections - Residential buildings

HOVE SA 5048

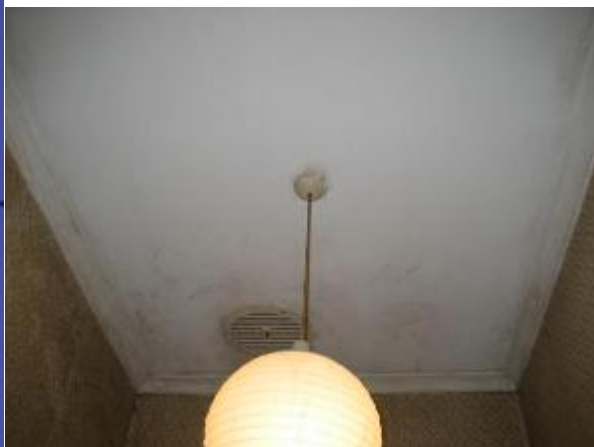
Ceilings & cornices      Mould      Safety Hazard      Type: C

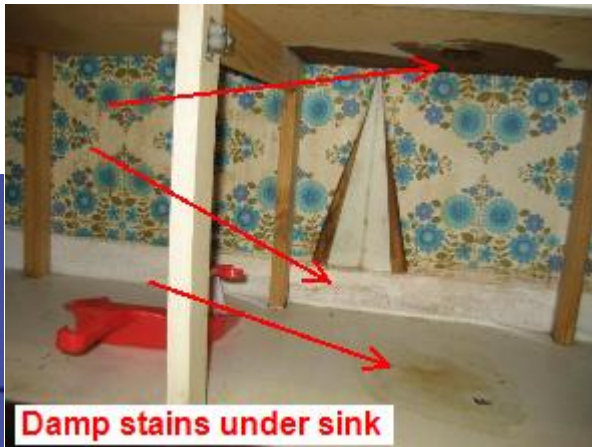
**Damp stains under sink**

Walls	Roughly finished crack repairs	Minor Defect	Type: B
Cupboards	Water damage	Minor Defect	Type: C
Taps	Leakage at tap	Major Defect	Type: C

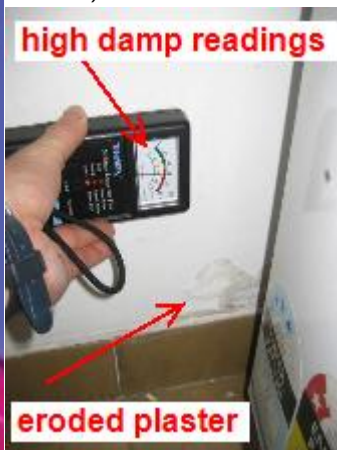
Walls	Damp - rising	Further Investigation	Type: C
-------	---------------	-----------------------	---------

*Damp was detected in the west laundry wall which may be from rising damp, a water leak in the pipe work (have a plumber pressure test the pipes) , damp via the adjacent concrete floor or even due to a leak from the holes in the outside steel gable cladding which has rusted holes (a rising damp specialist such as tech dry could do a more invasive inspection to determine a cause and fix the issue)*

**high damp readings**

**eroded plaster**

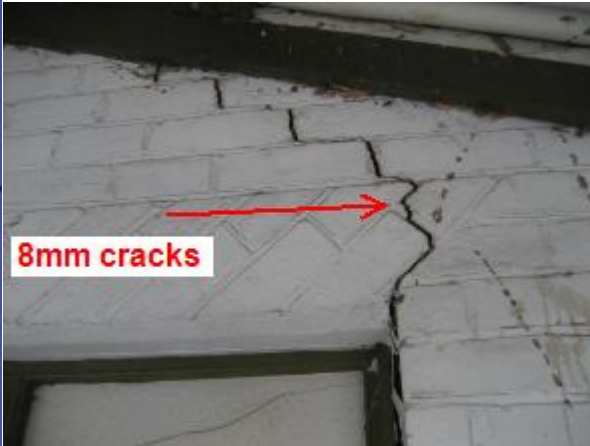
Cracking - category 3

*There are cracks up to category 3 in areas in the external walls throughout the house (above the bedroom 2 window especially), a structural engineer or cracking expert could be consulted before the cracks are repaired by a painter to reduce the likelihood of the cracks re-appearing again they may recommend installing systems such as control joints in the walls or underpinning, concrete footpaths to reduce subsidence and installing a proper stormwater system amongst other things.*

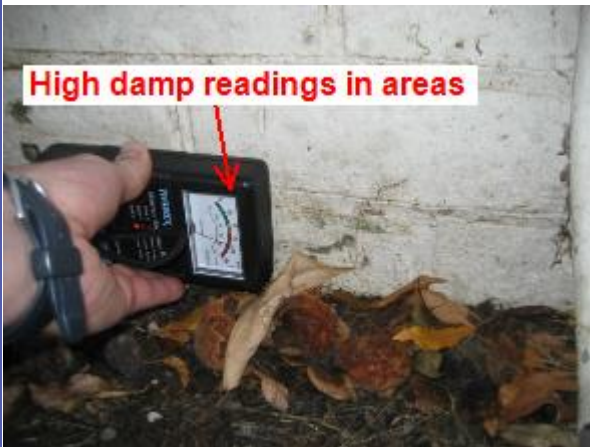
Damp - rising

*There is no damp proof course (DPC) installed as was typical in this era of construction, this may lead to rising damp issues in the outside and inside wall masonry, there is damp detected in some areas in the walls with only bubbled paint as visible damage at this stage( a company such as Tech dry can inject a silicone damp proof course if rising damp damage becomes a damage causing issue in the future).*

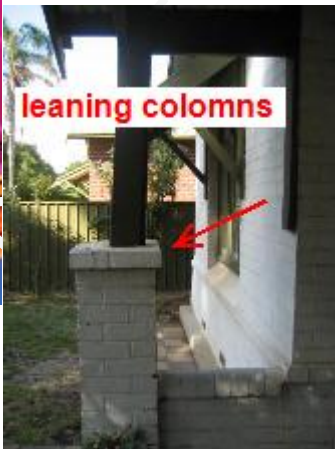
Rotation/out of vertical

*The front porch has high damp in the masonry walls, leaning columns and posts, rotten timber windows on the west side and poor roof cladding*

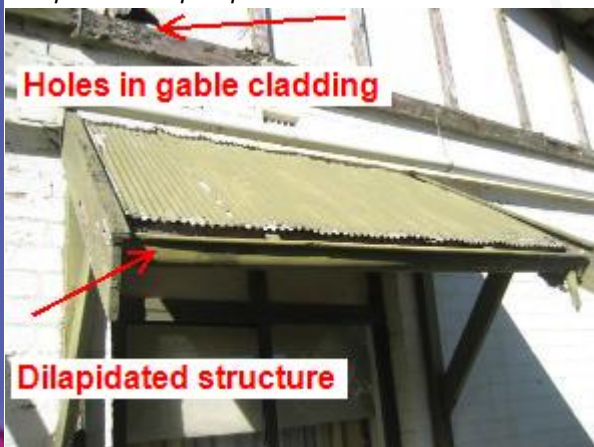
*There was high damp detected unusually high up in the walls on the west side which may be from rain leaking from the holes in the gable cladding which has rusted out along the bottom and should be replaced asap to prevent more moisture issues in the masonry walls.*

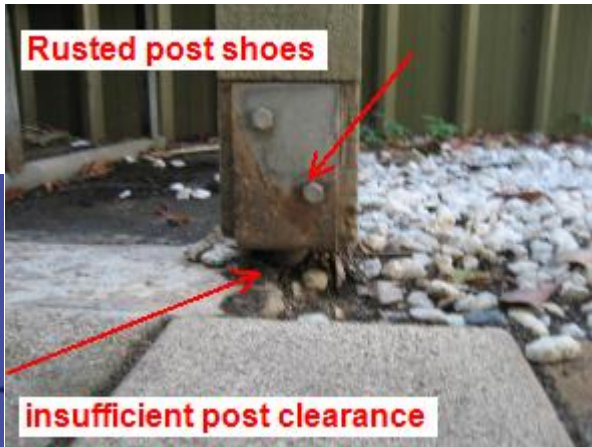
Patio/veranda	Insufficient clearances under post bases	Minor Defect	Type: F
---------------	--	--------------	---------

*The timber posts are susceptible to termite attack and fungal decay as they are at the paving level.*

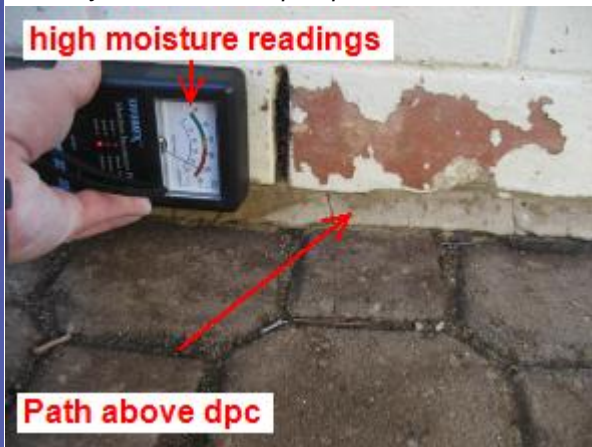
*When the path is at or above the damp proof course, termites may be able to enter the walls under the damp proof course unnoticed. Since 1995 Australian standards recommend that there must be 75mm of concrete slab exposed between any footpaths and the plastic damp proof course to allow inspection for termites. This house has less than 75mm in most areas, (consult a termite specialist to consider installing a termite prevention system to negate this issue). It may also allow damp to penetrate the bricks as shown in the photo below.*

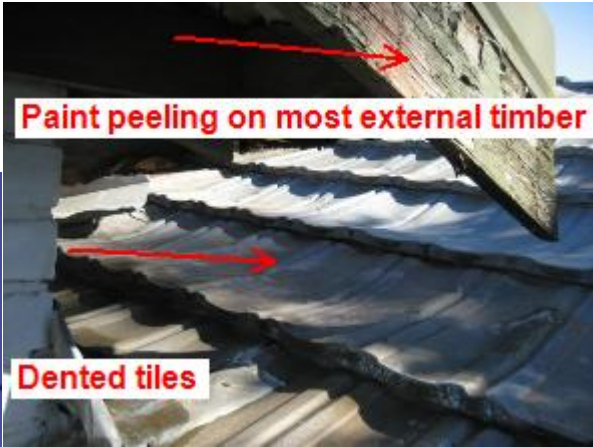
*The tin tiles are dented in most areas and have some rust spots and some are loose. I could not inspection the iron sheeting under the tin tiles.*

Paint peeling on most external timber

Dented tiles

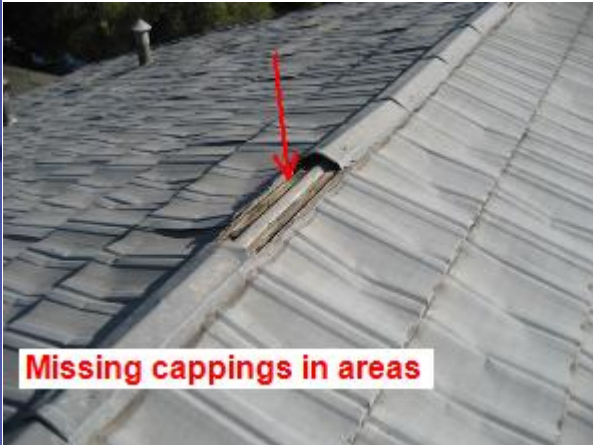
Some missing capping's may lead to rain entering the roof space and causing damage

Missing cappings in areas

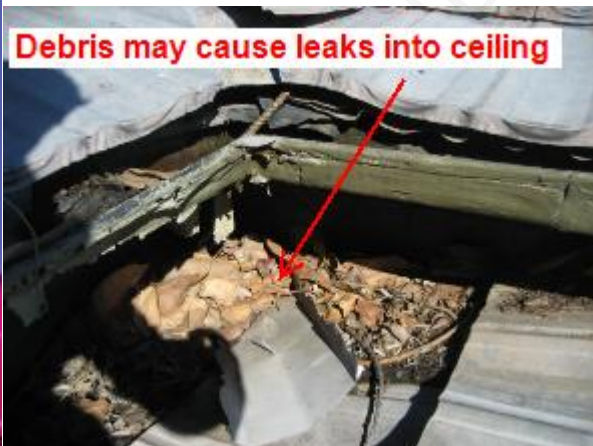
Debris may cause leaks into ceiling

Clean out all gutters etc as leaves may cause box gutters or flashings to overflow into the ceiling below.

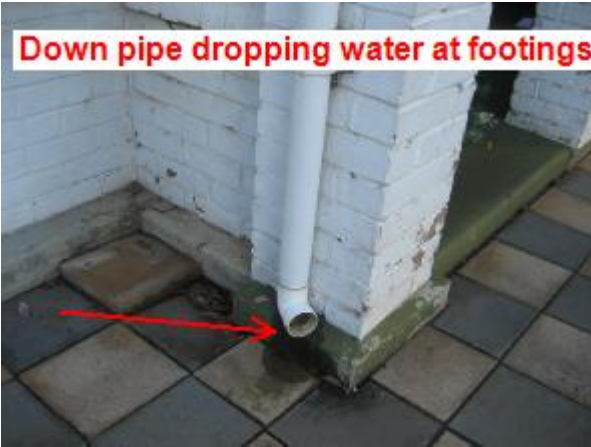
Down pipes dropping water at the footings can lead to subsidence, masonry cracking in the walls, rising damp and may also encourage termite attack as they like water sources near the dwelling. All downpipes should be connected to a proper storm water system.

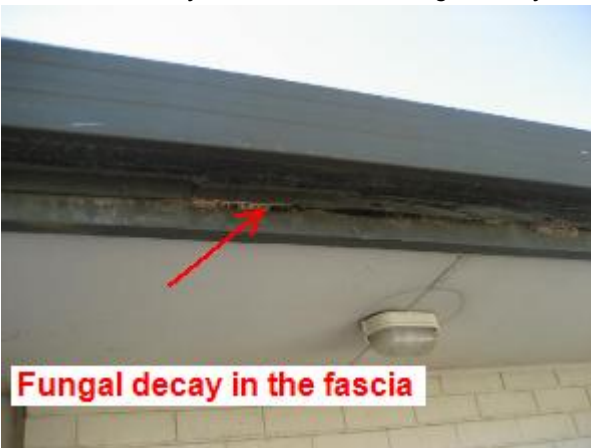
*The rear family room fascia has fungal decay as does the timber scotia*

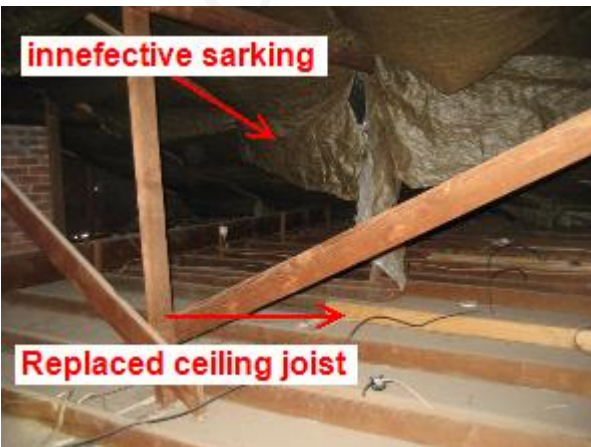
*The sarking covered the roof iron which meant I could not check the roof sheet integrity from underneath.*

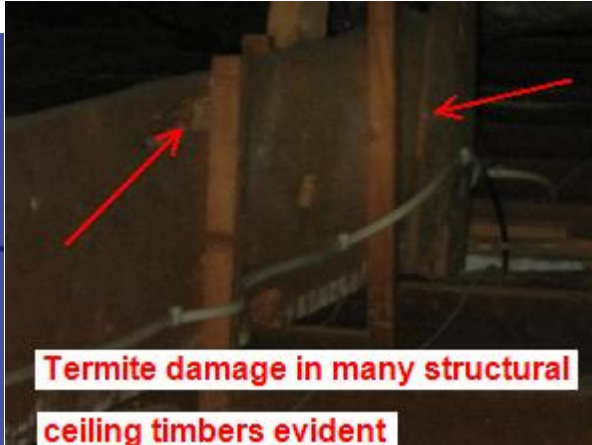
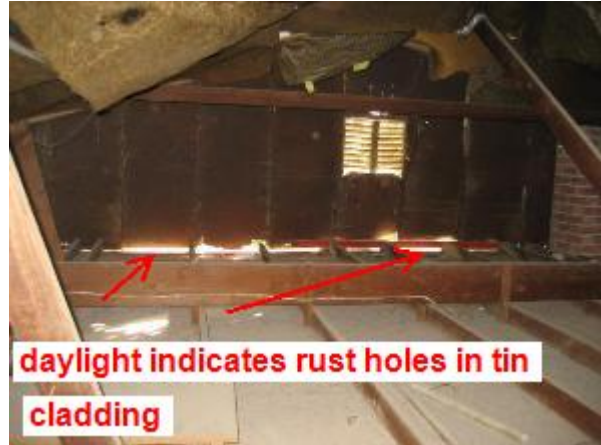
Roof framing                      Timber pest damage to framing                      Safety Hazard                      Type: A

*Many of the ceiling timbers have either been replaced or damaged by termites, a licensed builder will need to do a thorough invasive inspection to determine how much damage they have done and to decide what timbers require replacement.*

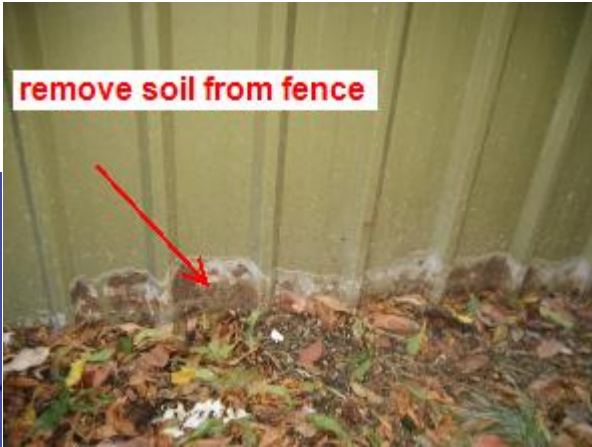
*Soil against the fence increase the rate of rust in the steel, remove the soil from against the fence sheets.*

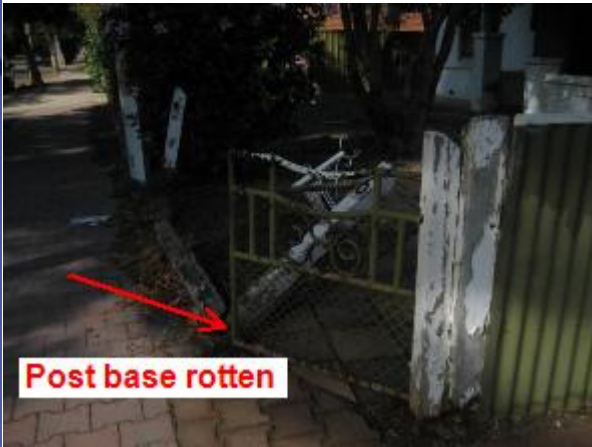
*The front fence has fallen over as the posts appear rotten at the base*

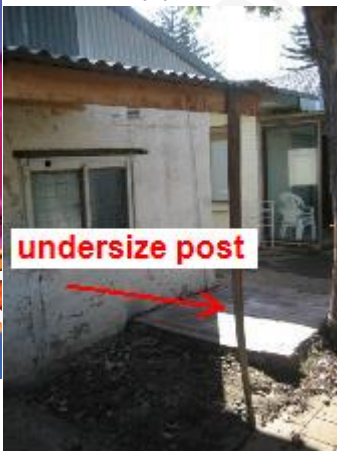
*The rear of the shed has a lean to with an under size post as pictured below.*

undersize post

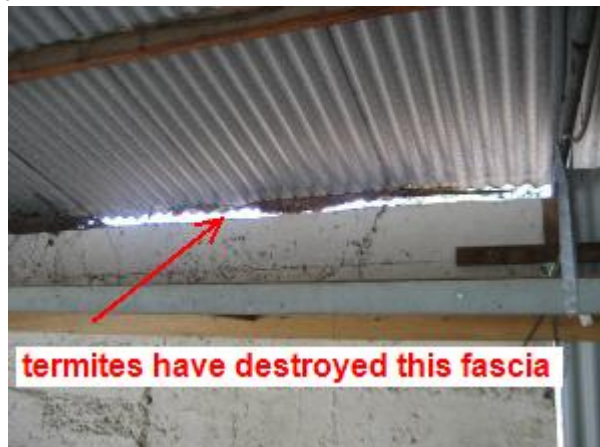
termites have destroyed this fascia
