## Visual Pre Purchase Timber Pest Inspection Report

To comply with Australian Standard AS4349.3-2007

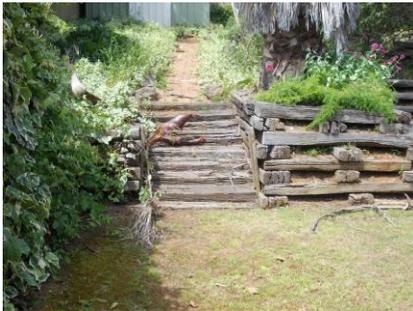
Sleeper retaining wall

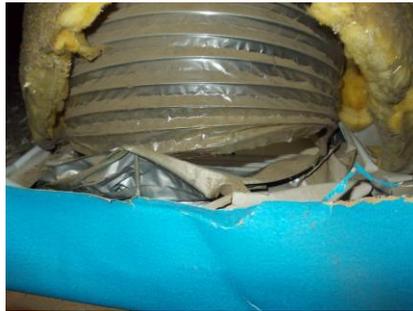
air conditioner duct

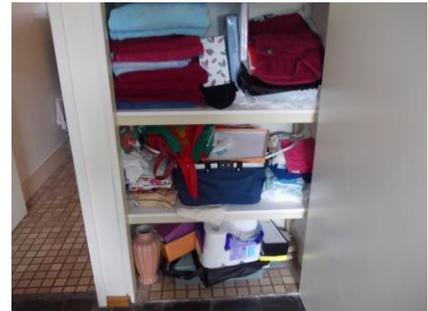
stored goods

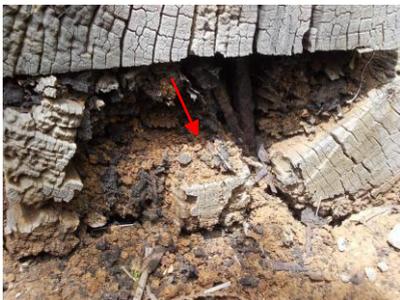
Where workings and / or damage was found, it was in but not necessarily limited to the following areas: Timber sleepers in the retaining walls, areas of pavers in the sheds

Termite damage to retaining wall

**This property was covered in termites, all the retaining wall sleeps have or have had termites and termite damage, the sheds have had termites in them and are showing signs that there are still active termites under the pavers in both sheds.**

**6.52 At the time of this inspection the DEGREE OF RISK OF SUBTERRANEAN TERMITE INFESTATION to the overall property was considered: **HIGH**.****6.53 SUBTERRANEAN TERMITE TREATMENT RECOMMENDATION:** A suitable management program in accordance with Australian Standards, AS 3660-2000 to protect against subterranean termites is considered to be **ESSENTIAL** and A **TERMITE MANAGEMENT CHEMICAL TREATMENT OR EXTERRA TERMITE INTERCEPTION AND MONITORING SYSTEM IS TO BE SOUGHT**.**6.54 FUTURE INSPECTIONS:** AS 3660.2-2000 recommends that inspections be carried out at intervals no greater than **ANNUALLY** and that, where timber pest “pressure” is greater, this interval should be shortened, E.G every three months until the termite issue is manageable. Inspections WILL NOT stop timber pest infestation; however, the damage which may be caused will be reduced when the infestation is found at an early stage.**6.55 RISK:** (THE WHAT IF FACTOR:) Due to the degree of risk of subterranean termite infestation noted above and all other findings of this report, it is essential that a full inspection and written report in accord with AS 4349.3 or AS 3660.2-2000 is conducted at this property every **3 MONTHS**.

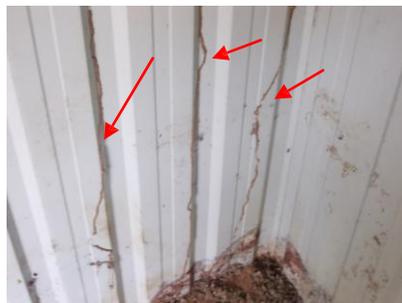
termite mudding on wall of shed

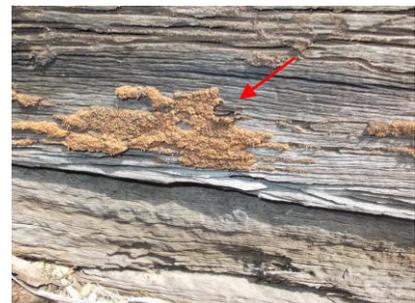
The termites, if evident have the potential to cause damage to structural and decorative timbers and were located mainly in, but not necessarily limited to, the following areas: Timber sleepers in the retaining walls, in the garden sheds

active termites in sleepers

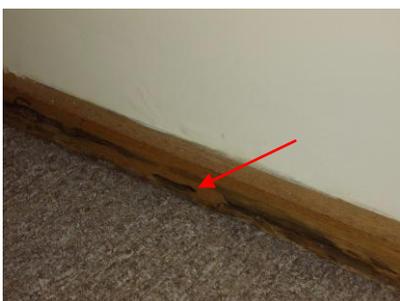
At the time of the inspection: HIGH MOISTURE READINGS WERE FOUND in the following locations: Areas of the tiles in the main bathroom shower alcove and the ensuite shower alcove, areas of the skirting board in bedroom 1 that backs the ensuite shower wall, ceiling in master bedroom

wood decay in skirting board

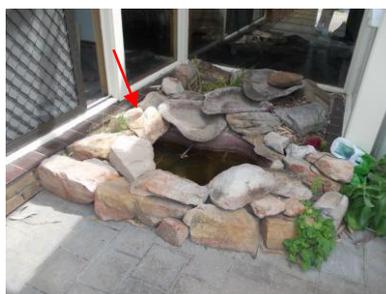
**6.44 Other areas and / or situations that appear conducive to (may attract) subterranean termite infestation:** Timber that is in contact with the ground is a conducive condition for termites, garden beds that are up to and over the damp course is a conducive condition for termites.

conductive conditions for termites

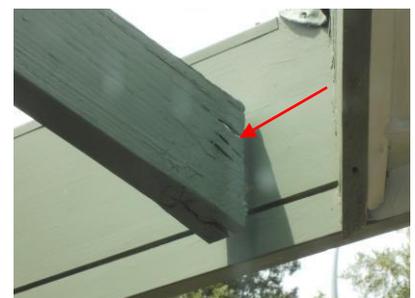
If YES the areas of the wood decay are located: in timbers of the pergolas, timber sleepers of the retaining walls, timber within the fence

wood decay
